Manhole Inspection Summary

Manhole # S23II_038MH

Location Address: **2334 PENNSYLVANIA AVE** Cross Street: **CUMBERLAND ST**

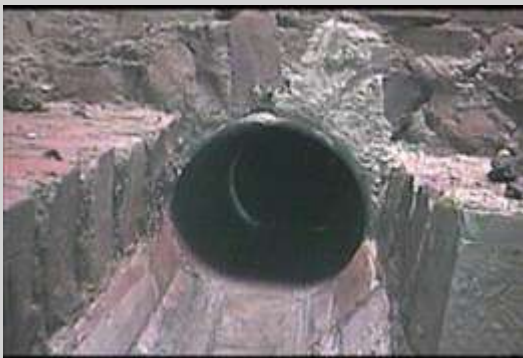
8 in. Circular Gravity Sewer Pipe In @ 6 O'Clock

Pipe Material: **Clay** ☐ Pipe Lined

Infiltration: **None** Pipe Seal Cond: **Sound**
